# 1956 AMC-Hudson

Groups 1.000 thru 13.000

# INDEX

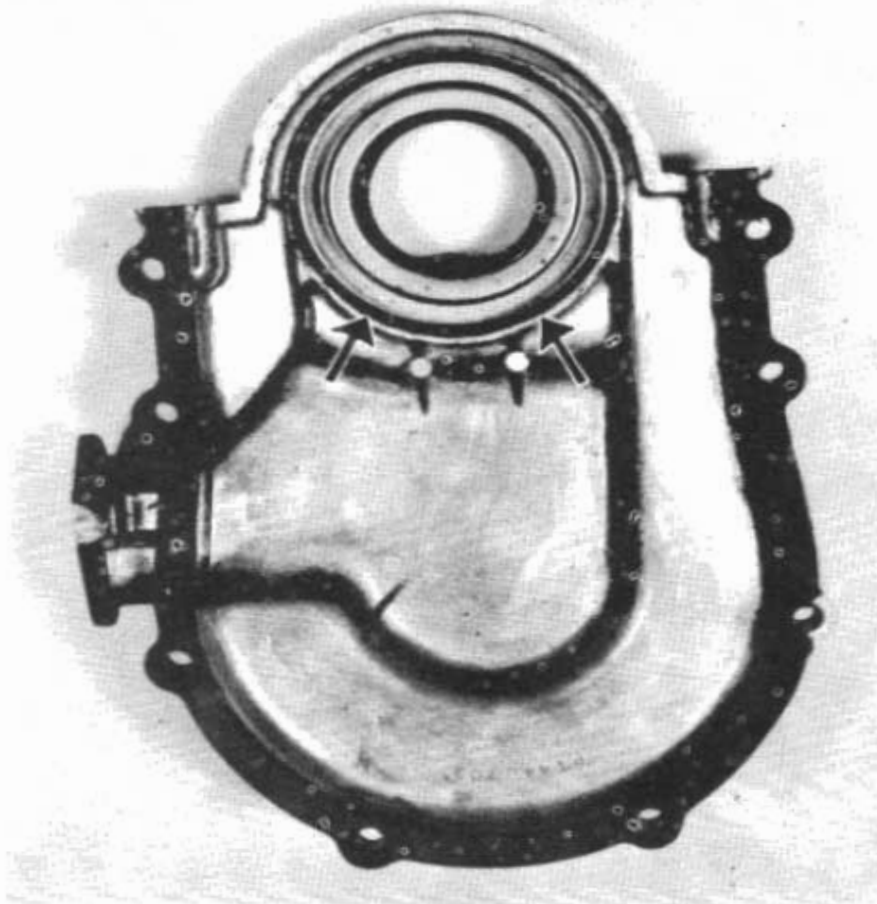
An oil leak at the front timing chain cover oil seal may result from a lack of an interference fit of the seal in the cover. This would permit the seal to turn with the crankshaft,

FIGURE 1  
Approximate Location of 11/64" Diameter Holes  
Drilled in Timing Chain Cover

To effect a correction for this condition, the following procedure is recommended:

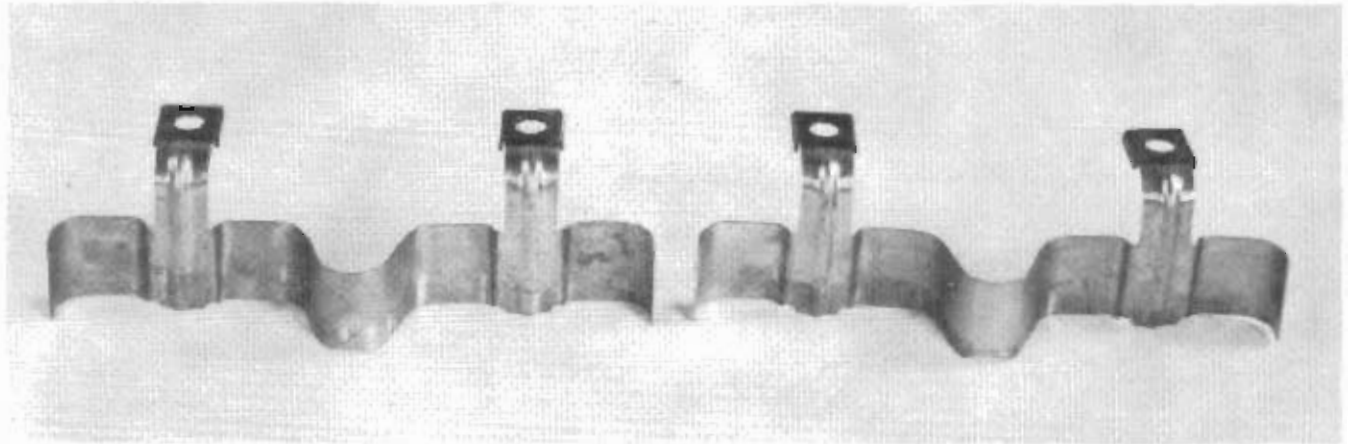
FIGURE 1

Valve Spring Baffles, Part Number 6489127,  
Contained in Kit, Part Number 6484396

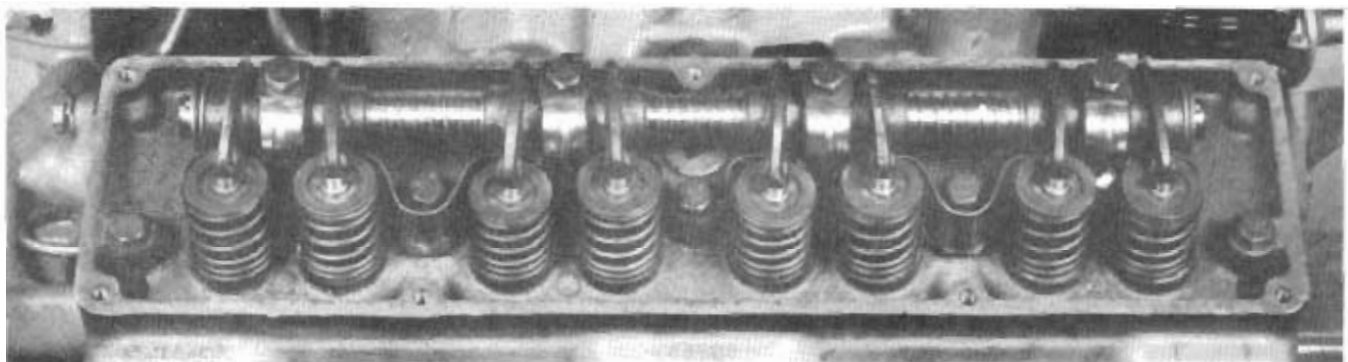
FIGURE 2

Service Baffles Installed

Place the baffles in position on the rocker arm assembly as shown in Figure 2. Install the assembly on the cylinder head. Replace the original rocker arm shaft bolt lockwashers with the square type lockwashers.

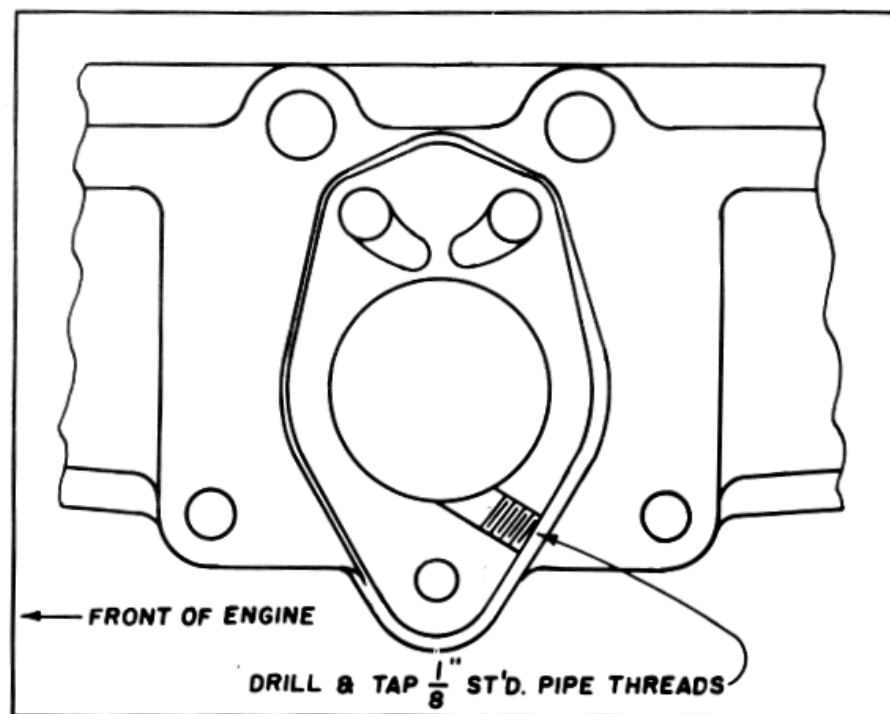
FIGURE 1

Rough engine idle caused by windshield wiper operation may be improved by relocating the vacuum booster pump outlet connection to the left rear side of the intake manifold cover carburetor mounting pad.

Mark and drill a  $21/64$ " hole in the left rear side of the carburetor mounting pad as shown in the illustration.

Tap the hole with a  $1/8$ " standard tapered pipe thread.

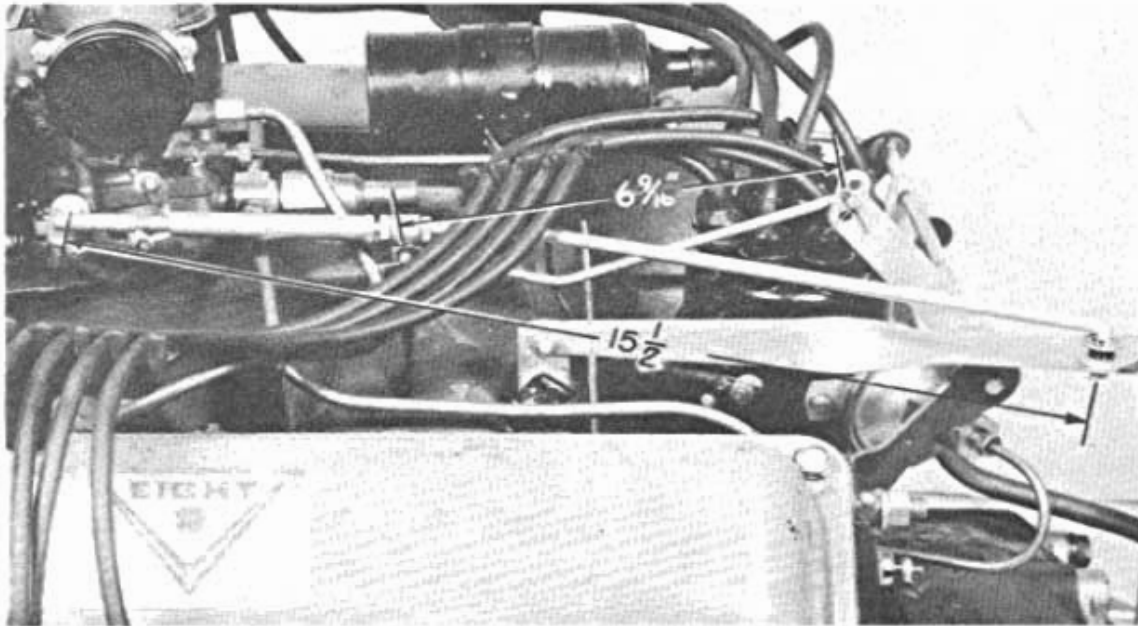
FIGURE 1  
CARBURETOR THROTTLE ROD AND  
ADJUSTER ROD MEASUREMENT

After measurement, have been corrected, warm up engine and set carburetor idle at 400 RPM. Stop the engine and loosen the two lock nuts at the front and rear end of the adjuster on the rod. **PLACE THE REAR END OF THE ROD IN THE CENTER HOLE OF THE CROSS SHAFT LEVER.** Finger tighten the two lock nuts so that the adjuster rod fits freely in the lever.

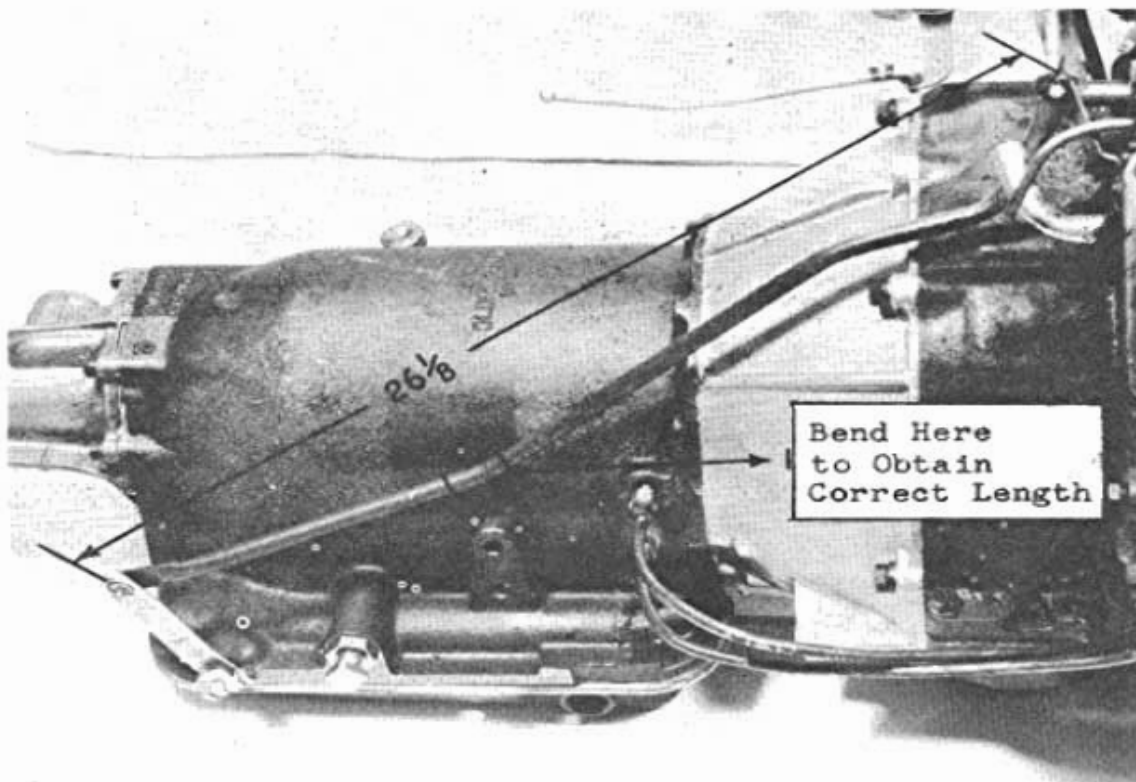
FIGURE 2  
T.V. ROD MEASUREMENT

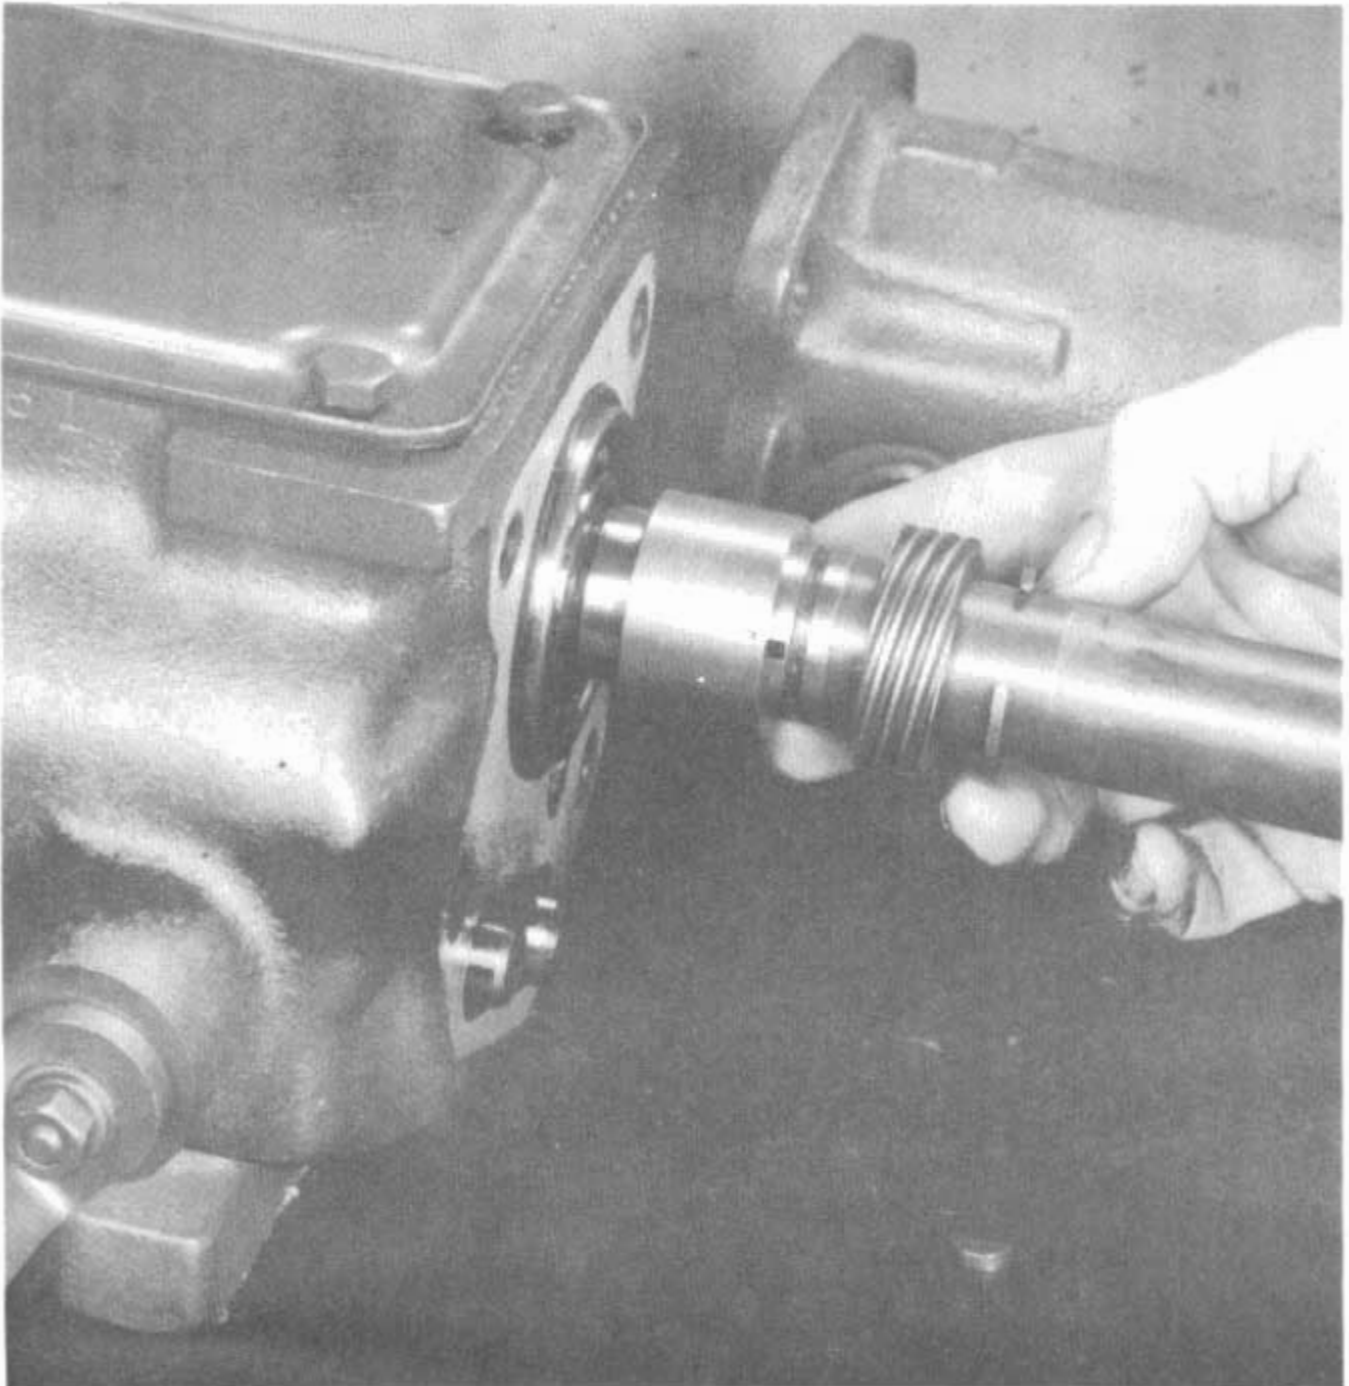
REAR BEARING SNAP RING FAILURE,  
STANDARD TRANSMISSION - 1955-56  
"40" SERIES

SLEEVE, PART NUMBER 3149883  
1955-56 "40" SERIES STANDARD TRANSMISSION

Where failure of this nature is encountered, install sleeve, Part Number 3149883, (supplied for service only) by removing the rear extension housing, three snap rings, and speedometer drive gear.

Install the sleeve against the bearing and replace the Woodruff key and speedometer drive gear. Select fit one snap ring in the groove at the rear of the speedometer drive gear to provide zero end clearance.

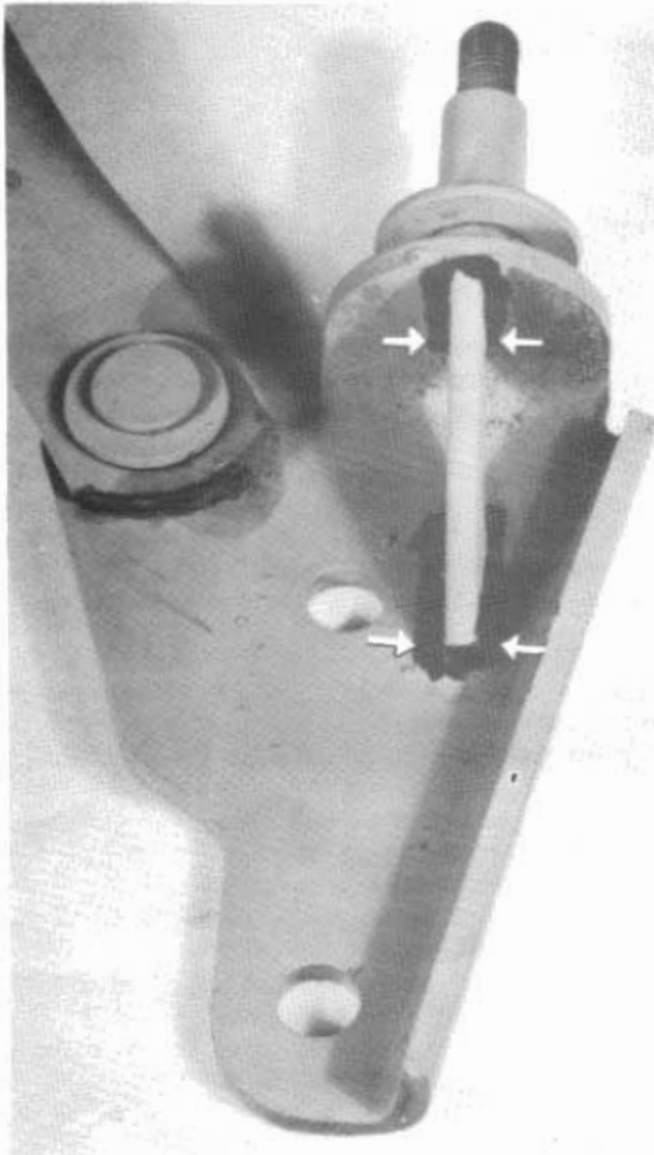
FIGURE 1  
Shock Absorber Lower Mounting  
Bracket Brace
